Manhole Inspection Summary

Manhole # S15II1002MH

Location Address: **4209 ROLAND VIEW AVE**

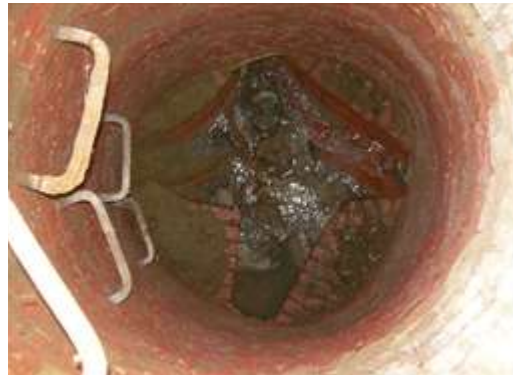
Top View

Evidence of surcharge - Bench debris.
Corroded steps. Channel debris.

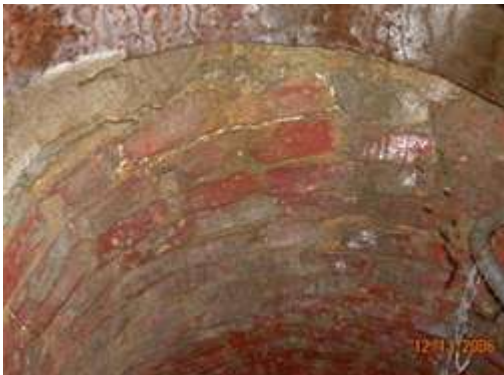
Defect

Adjustment deterioration and infiltration.
Corbel infiltration.

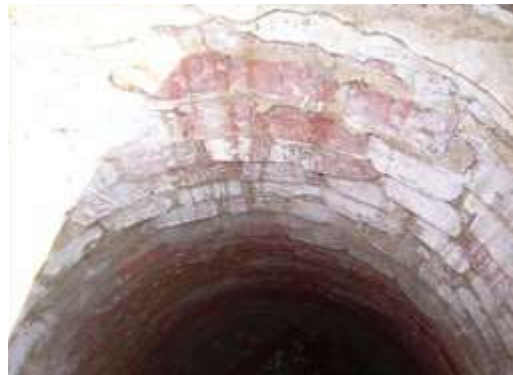
Defect

Adjustment deterioration and infiltration.
Corbel and Barrel infiltration.

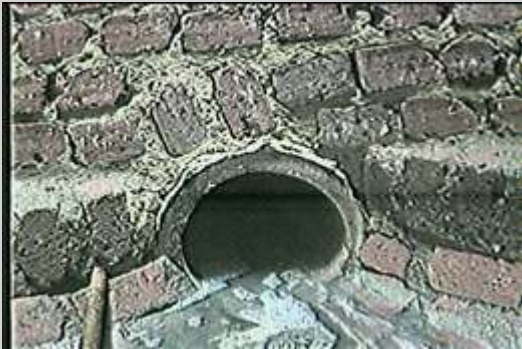
8 in. Circular Gravity Sewer Pipe Out @ 12 O'Clock

Barrel deterioration and infiltration. Channel deterioration.

Deposits: ☐ None ☐ Mud ☐ Sludge ☒ **Debris** ☐ Grease

Silt Depth: **0.5** (in.) Deposits Extent: **Light**

Infiltration: **Evidence** Pipe Seal Cond: **Unknown**

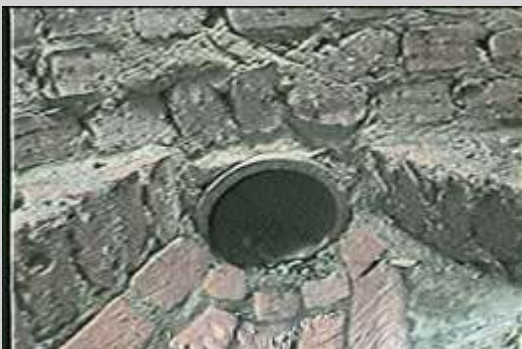
6 in. Circular Gravity Sewer Pipe In @ 4 O'Clock

Barrel deterioration and infiltration. Channel deterioration.

Deposits: ☐ None ☒ **Mud** ☐ Sludge ☒ **Debris** ☐ Grease

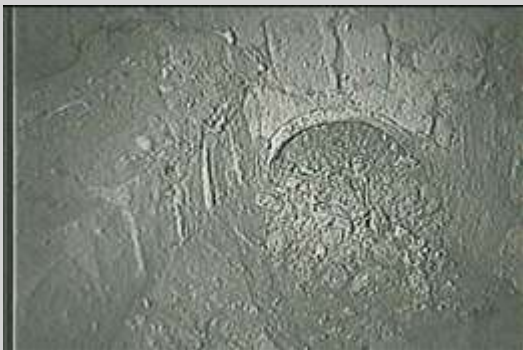
Pipe In @ 9 O'Clock

Deposits: ☐ None ☒ **Mud** ☐ Sludge ☒ **Debris** ☐ Grease

Silt Depth: **5** (in.) Deposits Extent: **Heavy**

Infiltration: **Evidence** Pipe Seal Cond: **Unknown**
